OLD GOLD?

FORD SIERRA

AGEING SIERRAS ARE CHEAP BUT SPECIAL CARE IS NEEDED WHEN BUYING, says Kim Henson.

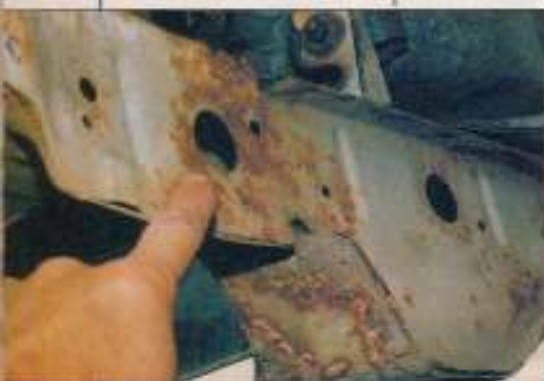
Front crossmember and surrounding structure are usually hidden by engine. However, closely inspect the vitally important steelwork here. If corrosion is widespread look for another car.

Rust can strike virtually anywhere, but particularly in the front and rear extremities of the 'chassis' runners, sill assemblies, front and rear valance panels, front cross-member and adjacent structural beams, suspension mounting points, floor pans, screen pillars and bulkhead/door pillar assemblies. If rust is found in the rear 'chassis', the fuel tank will have to come out for repairs. Inspect the rear structure from within the boot and from under the vehicle.

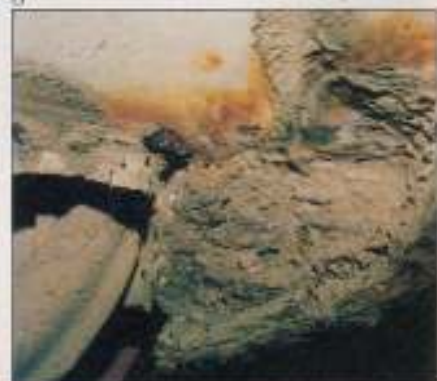
From within each rear wheelarch, look forwards and establish condition of 'splash' panel, sill rear end and structure supporting rear suspension arm. Serious rust here is very bad news.

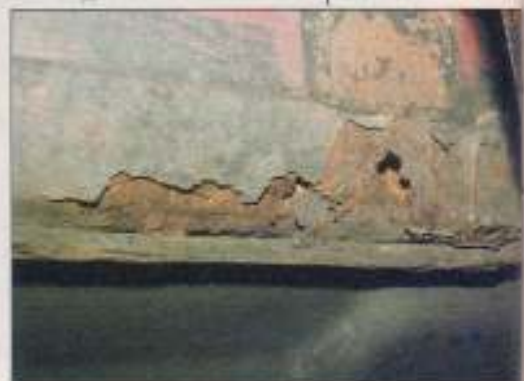
Sills are often weak, and the lower edges are especially vulnerable. If you are looking at a mixture of holes, rusty steel and various patches, bargain on extensive repairs further in!

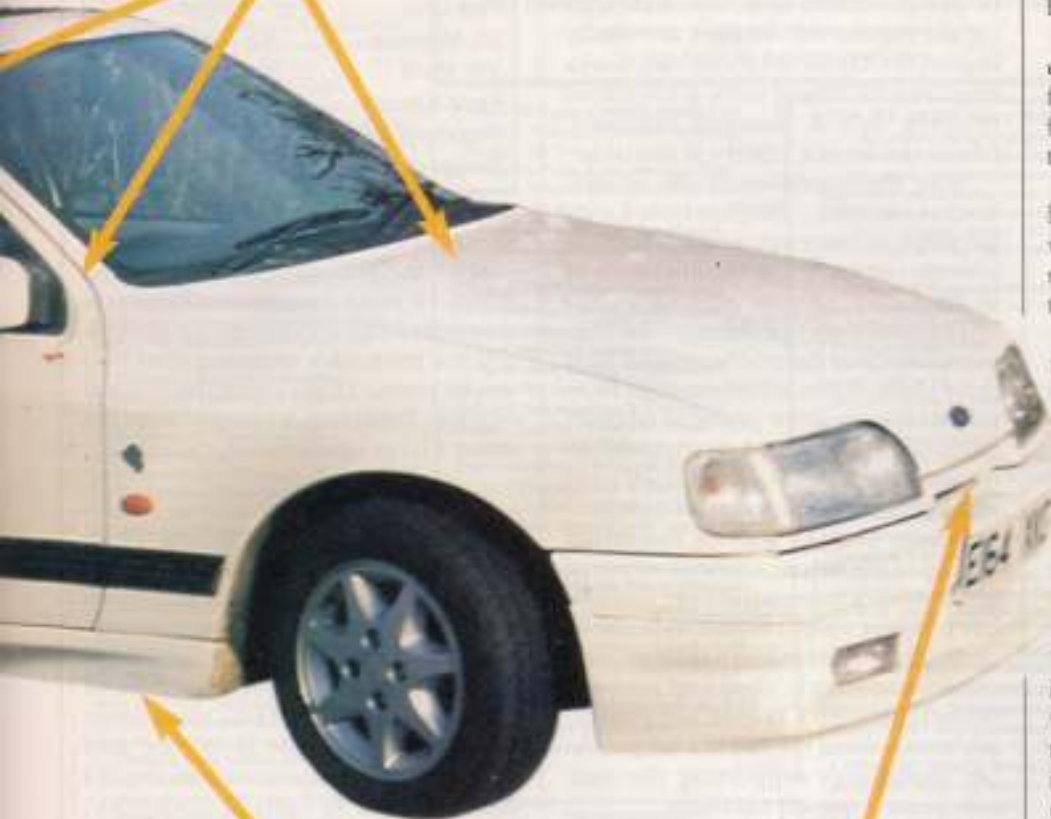
WATCH FOR RUST IN REAR CHASSIS SECTIONS AND BOOT FLOOR, ALSO BASES OF REAR WINGS

CORROSION IN DOORS CAN BE RAMPANT

CHECK FOR ROT IN
SCREEN PILLARS, DOOR PILLARS
AND BULKHEADS

CHASSIS
RUNNERS AND SILLS CAN
HARBOUR RUST

STRUCTURE AT
FRONT OF CAR MAY
BE CRUMBLING

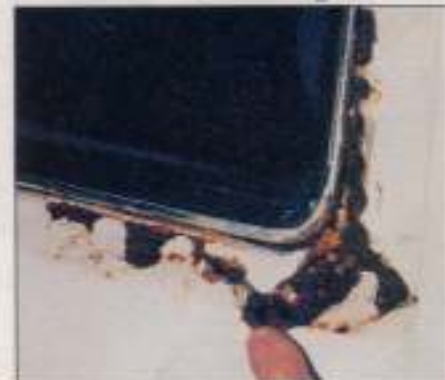
Doors can be very rusty, even on cars only a few years old. Start by inspecting the sloping 'edges' immediately below the windows. Look for glass fibre and body filler, as well as 'honest' rust!

Outer body panels aren't immune either. The doors are especially vulnerable; check under and around the window frames, and along the lower

edges (view from outside and underneath). Both front and rear wings can disintegrate too – particularly around the arches, also the sections normally hidden by the bumpers.

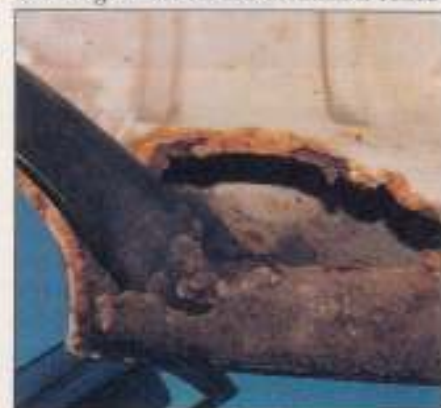
Don't be deceived by a bonnet which looks good from outside. Open it and view the underside of the assembly from below. The leading edge collects moisture and salt, then holes appear.

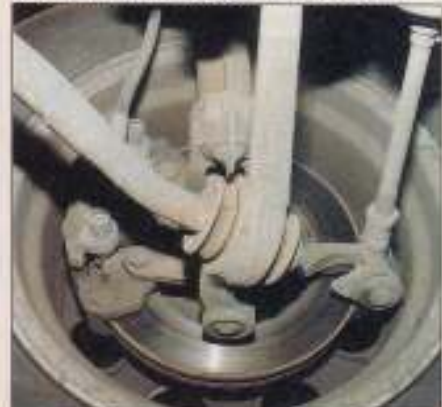
Front suspension and steering require close scrutiny, especially the multitude of rubber bushes, brake discs (they often wear rapidly), and the steering rack (watch for torn gaiters).

Ensure that all rubber mounting bushes in the suspension system are in good condition (especially the anti-roll bar to lower suspension arm bushes), or the car will drive 'like a sponge' (you can feel the vehicle 'shunting' on worn bushes) and MoT failure will eventually result. Vital too are the large rubber mountings supporting the rear sub-frame – inspect carefully.

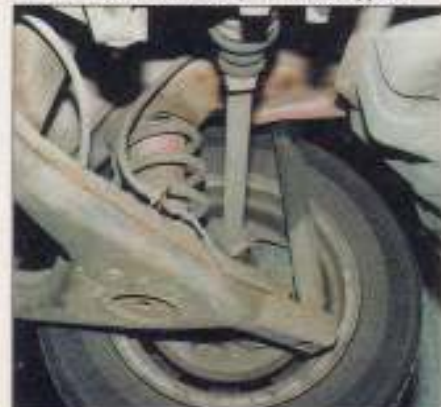
At the rear, check out the driveshaft gaiters, mounting bushes for the rear sub-frame/trailing arms, and condition of the steel suspension components. Deficiencies here spell MoT failure.

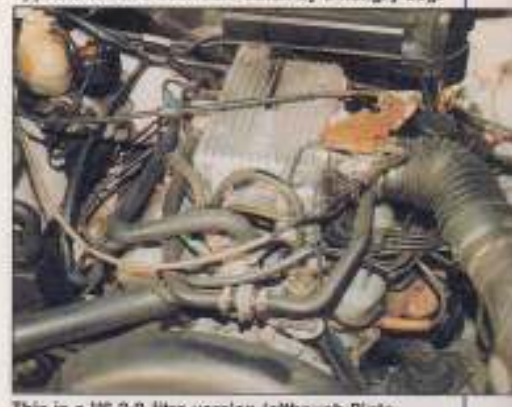
This is a V6 2.8-litre version (although Pinto powered Sierras predominate). Check for oil leaks, 'top end' noise and timing gear rattle. On Pinto units, watch for oil leaks and smoking, and listen for clattering from worn camshaft/followers.

The 2.3 and 2.8-litre V6 'Cologne' engines are pretty reliable, but again infrequent oil/filter changes result in

premature valve gear wear (pushrods and tappets) and 'top end noise'. The timing gears can also wear/rattle.
