Running Report: 1991 Ford Sierra Ghia, 2295cc - Mileage: 186,500 By Jim Christie

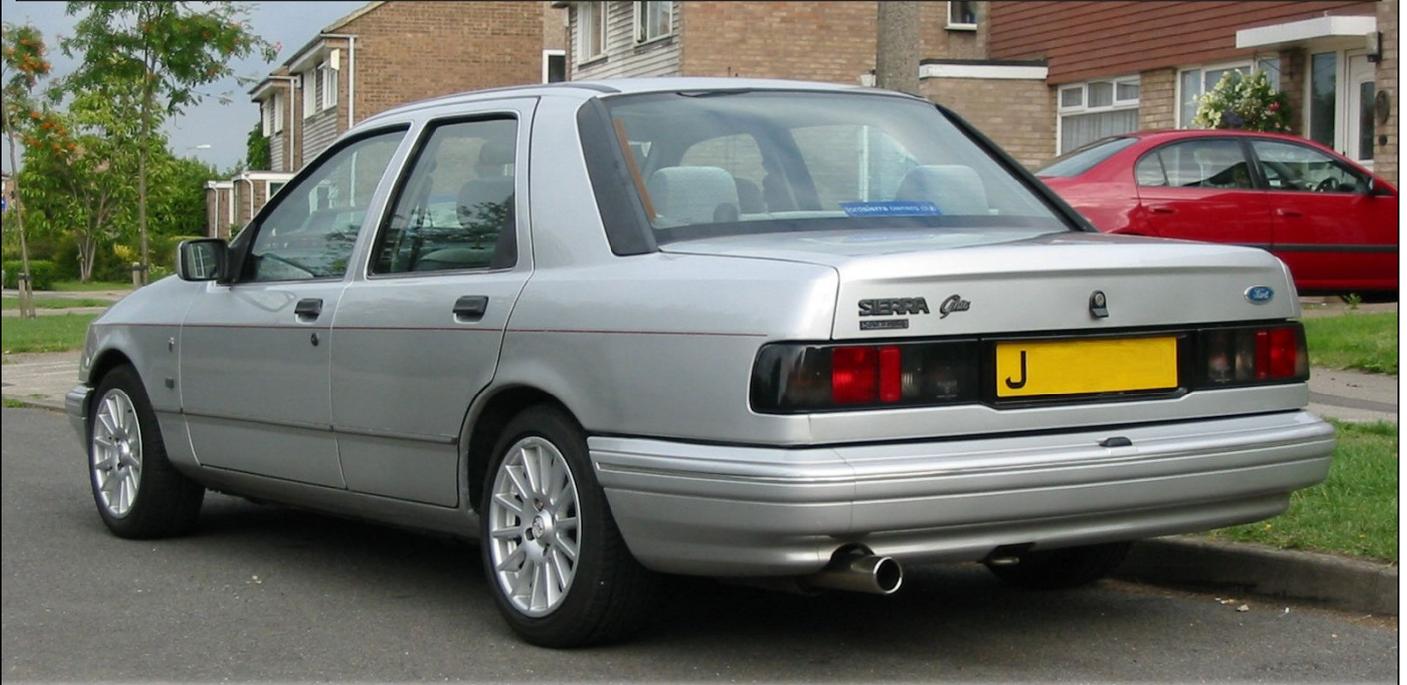
No, as far as I'm aware, they didn't. But I'm not talking about a diesel Sierra. Since I last wrote a running report for the club magazine, "Ghia of Fear" has been undergoing a bit of open heart surgery all in the name of experimentation - and has what is believed to be the first hybrid 2.3 8-valve DOHC engine in the country, certainly in a Sierra.

Formed from a melding of a Ford Scorpio 2.3 16v DOHC bottom end and Sierra 2.0 DOHC cylinder head, the 2.3 8v twin-cam hybrid coughed into life on 11th November 2006 to high expectation. Actually, I thought it would just blow up on the spot, or simply (and singularly unspectacularly) not start at all. But no - to say I was pleasantly surprised would definitely be an understatement!

The engine features a Janspeed 4-branch exhaust manifold, K&N filter and a powerchip - which is the beauty of it: by retaining the Sierra 8v DOHC cylinder head, the Sierra manifolds and all the sensors plug straight in making installation a pretty much "plug and play" affair - 2.0 engine comes out and 2.3 goes straight in - to all intents and purposes looks like a standard 2.0 twin-cam too.
